BUREAU OF SHIPS GROUP TECHNICAL INSPECTION REPORT

OPERATION CROSSROADS. U.S.S. INDEPENDENCE (CVL22)

TEST ABLE

VOLUME 1 OF 4 [U].

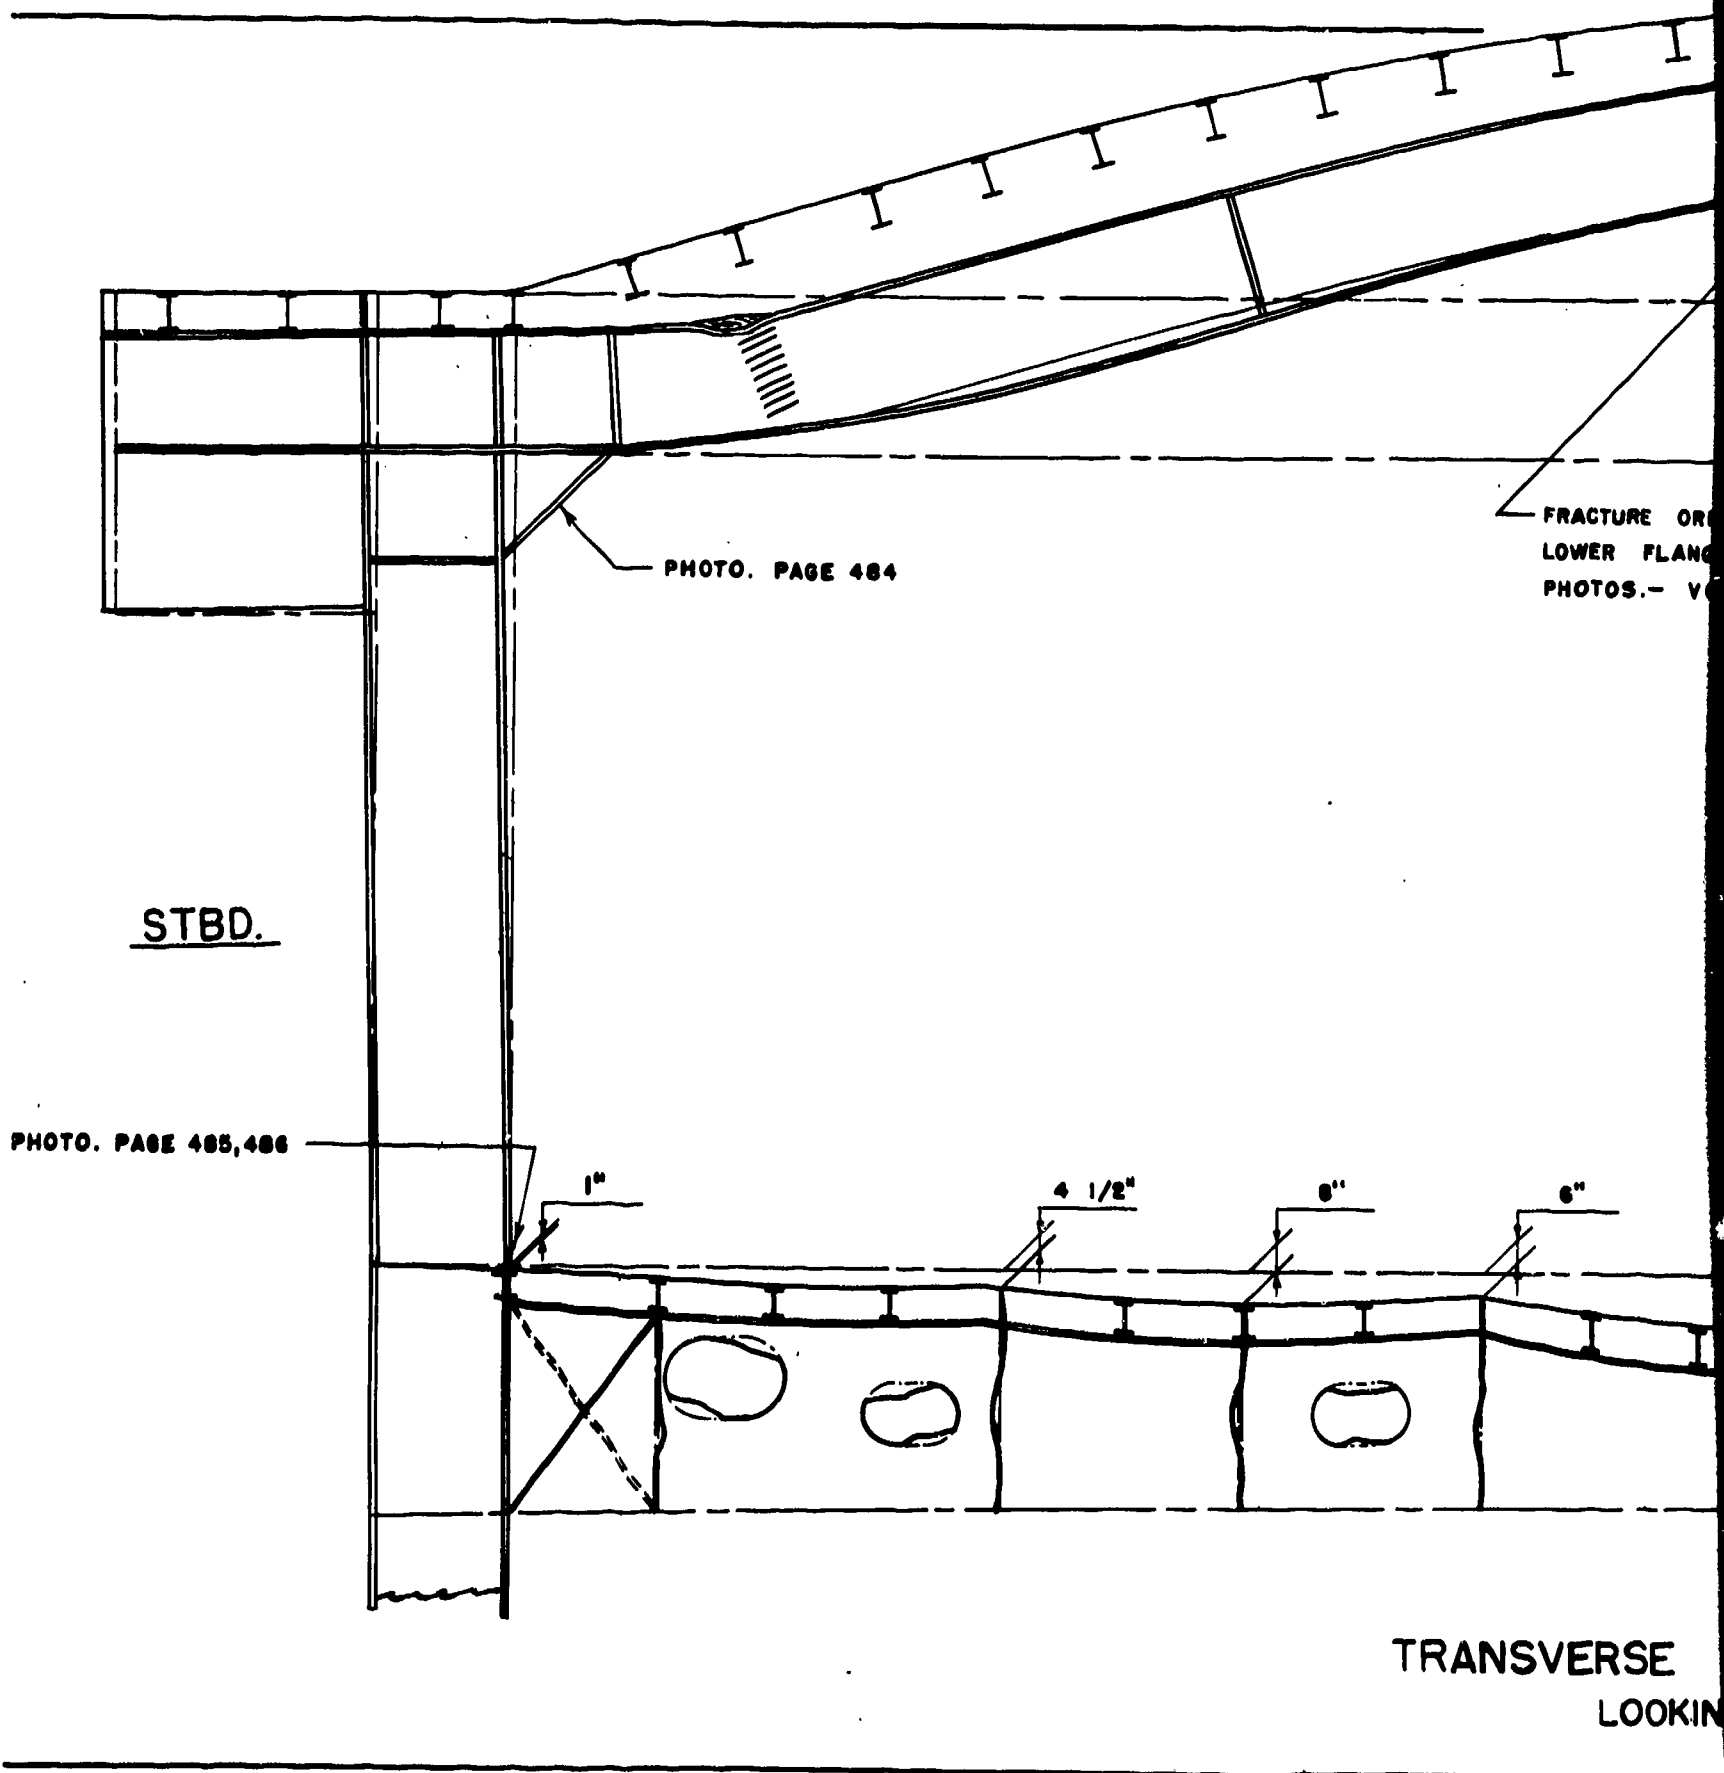
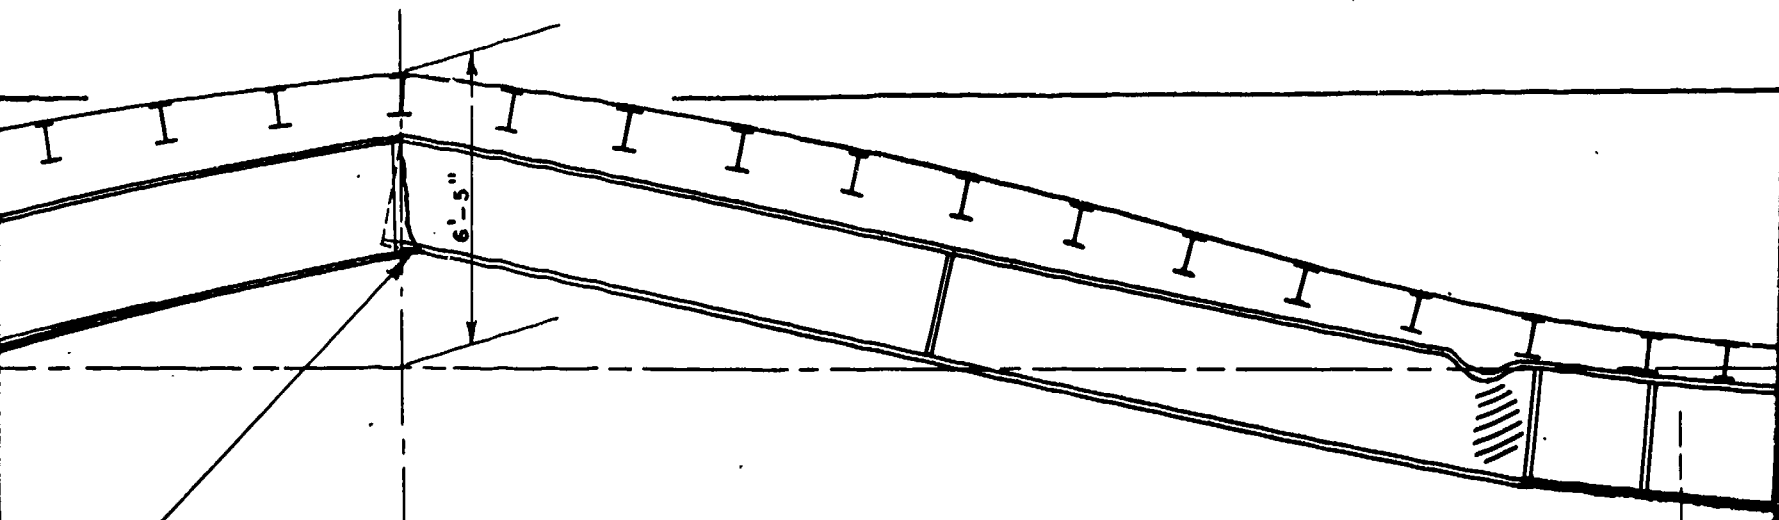
FRACTURE ORIGINATED IN BUTT WELD IN
LOWER FLANGE OF GIRDER.
PHOTOS.— VOL. 3, PAGES 475-483

FRACTURE ORIGINATED IN WELD JOINING
BRACKET FLANGE TO TRANSVERSE GIRDER.
WELDS TOO SMALL TO DEVELOP 100%
JOINT EFFICIENCY.
PHOTOS.— VOL. 3, PAGES 473, 474

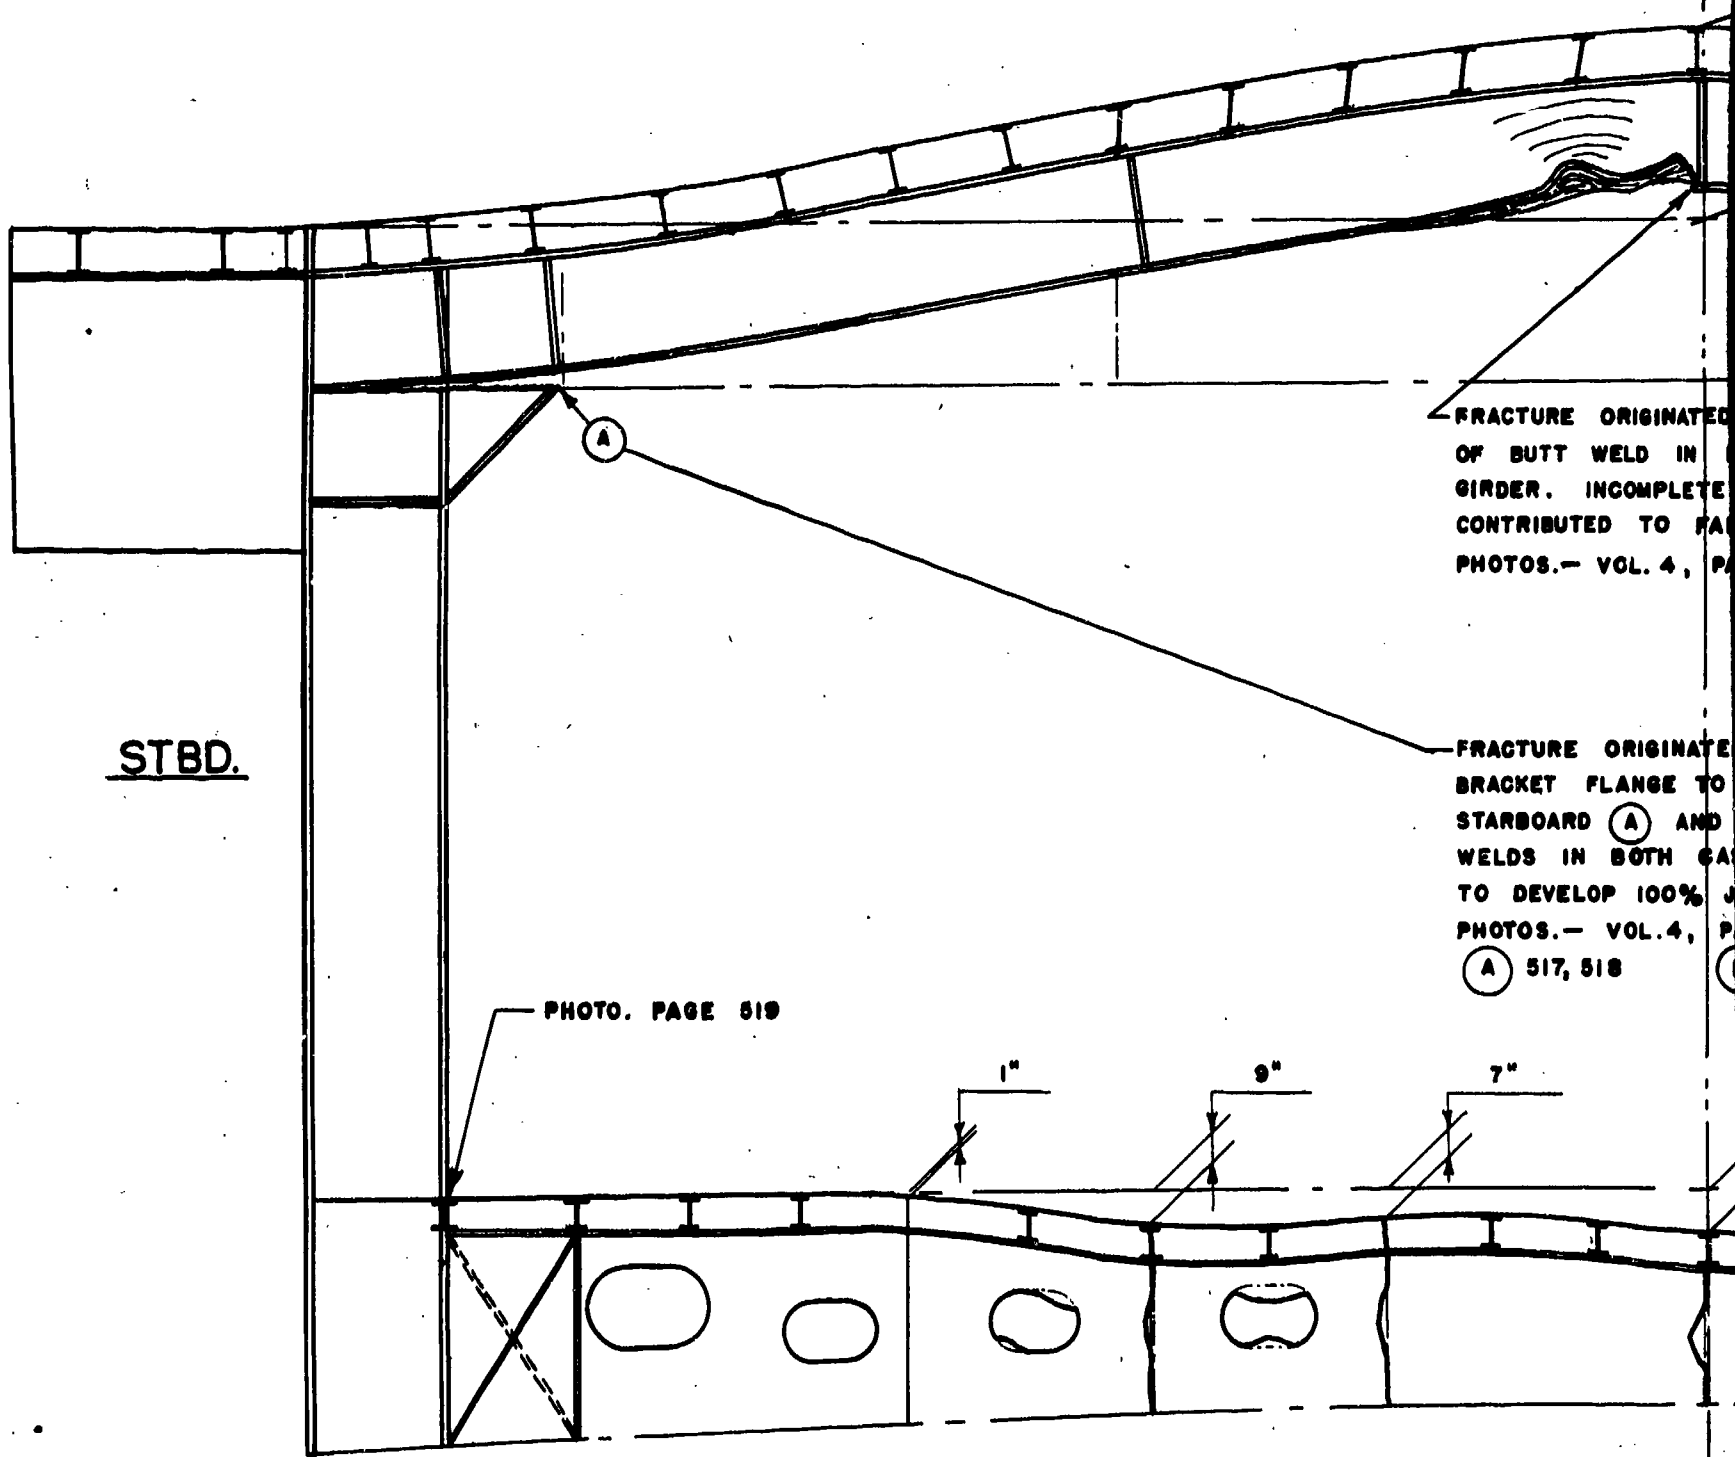
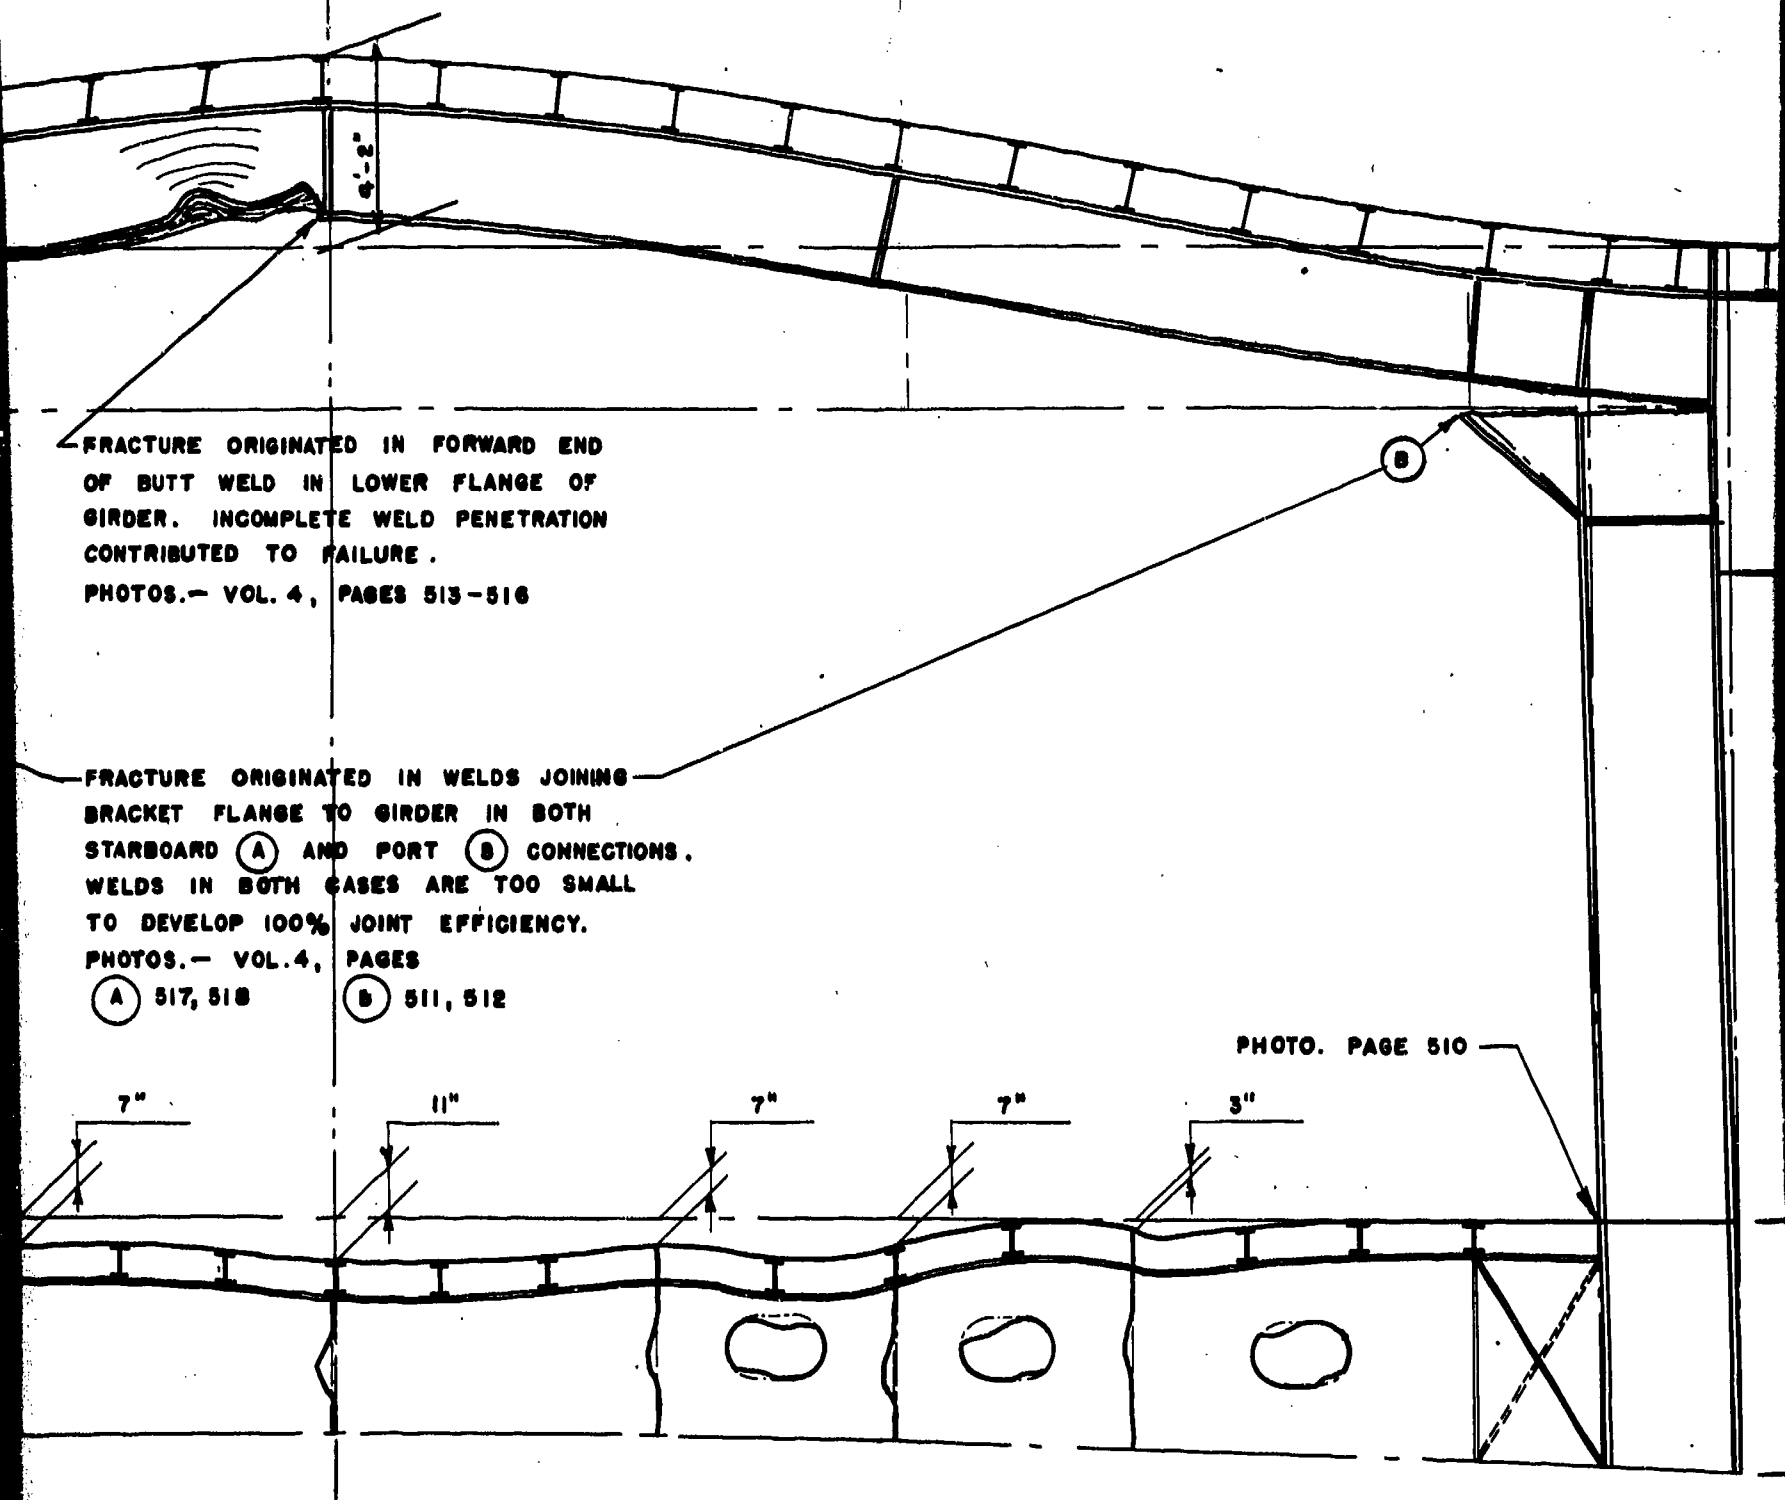
FRACTURE ORIGINATED
OF BUTT WELD IN
GIRDER. INCOMPLETE
CONTRIBUTED TO FAILURE
PHOTOS.— VOL. 4, PAGE 518

FRACTURE ORIGINATED
BRACKET FLANGE TO
STARBOARD (A) AND
WELDS IN BOTH CASES
TO DEVELOP 100% JOINT
PHOTOS.— VOL. 4, PAGE 518
(A) 517, 518

FRACTURE ORIGINATED IN FORWARD END
OF BUTT WELD IN LOWER FLANGE OF
GIRDER. INCOMPLETE WELD PENETRATION
CONTRIBUTED TO FAILURE.

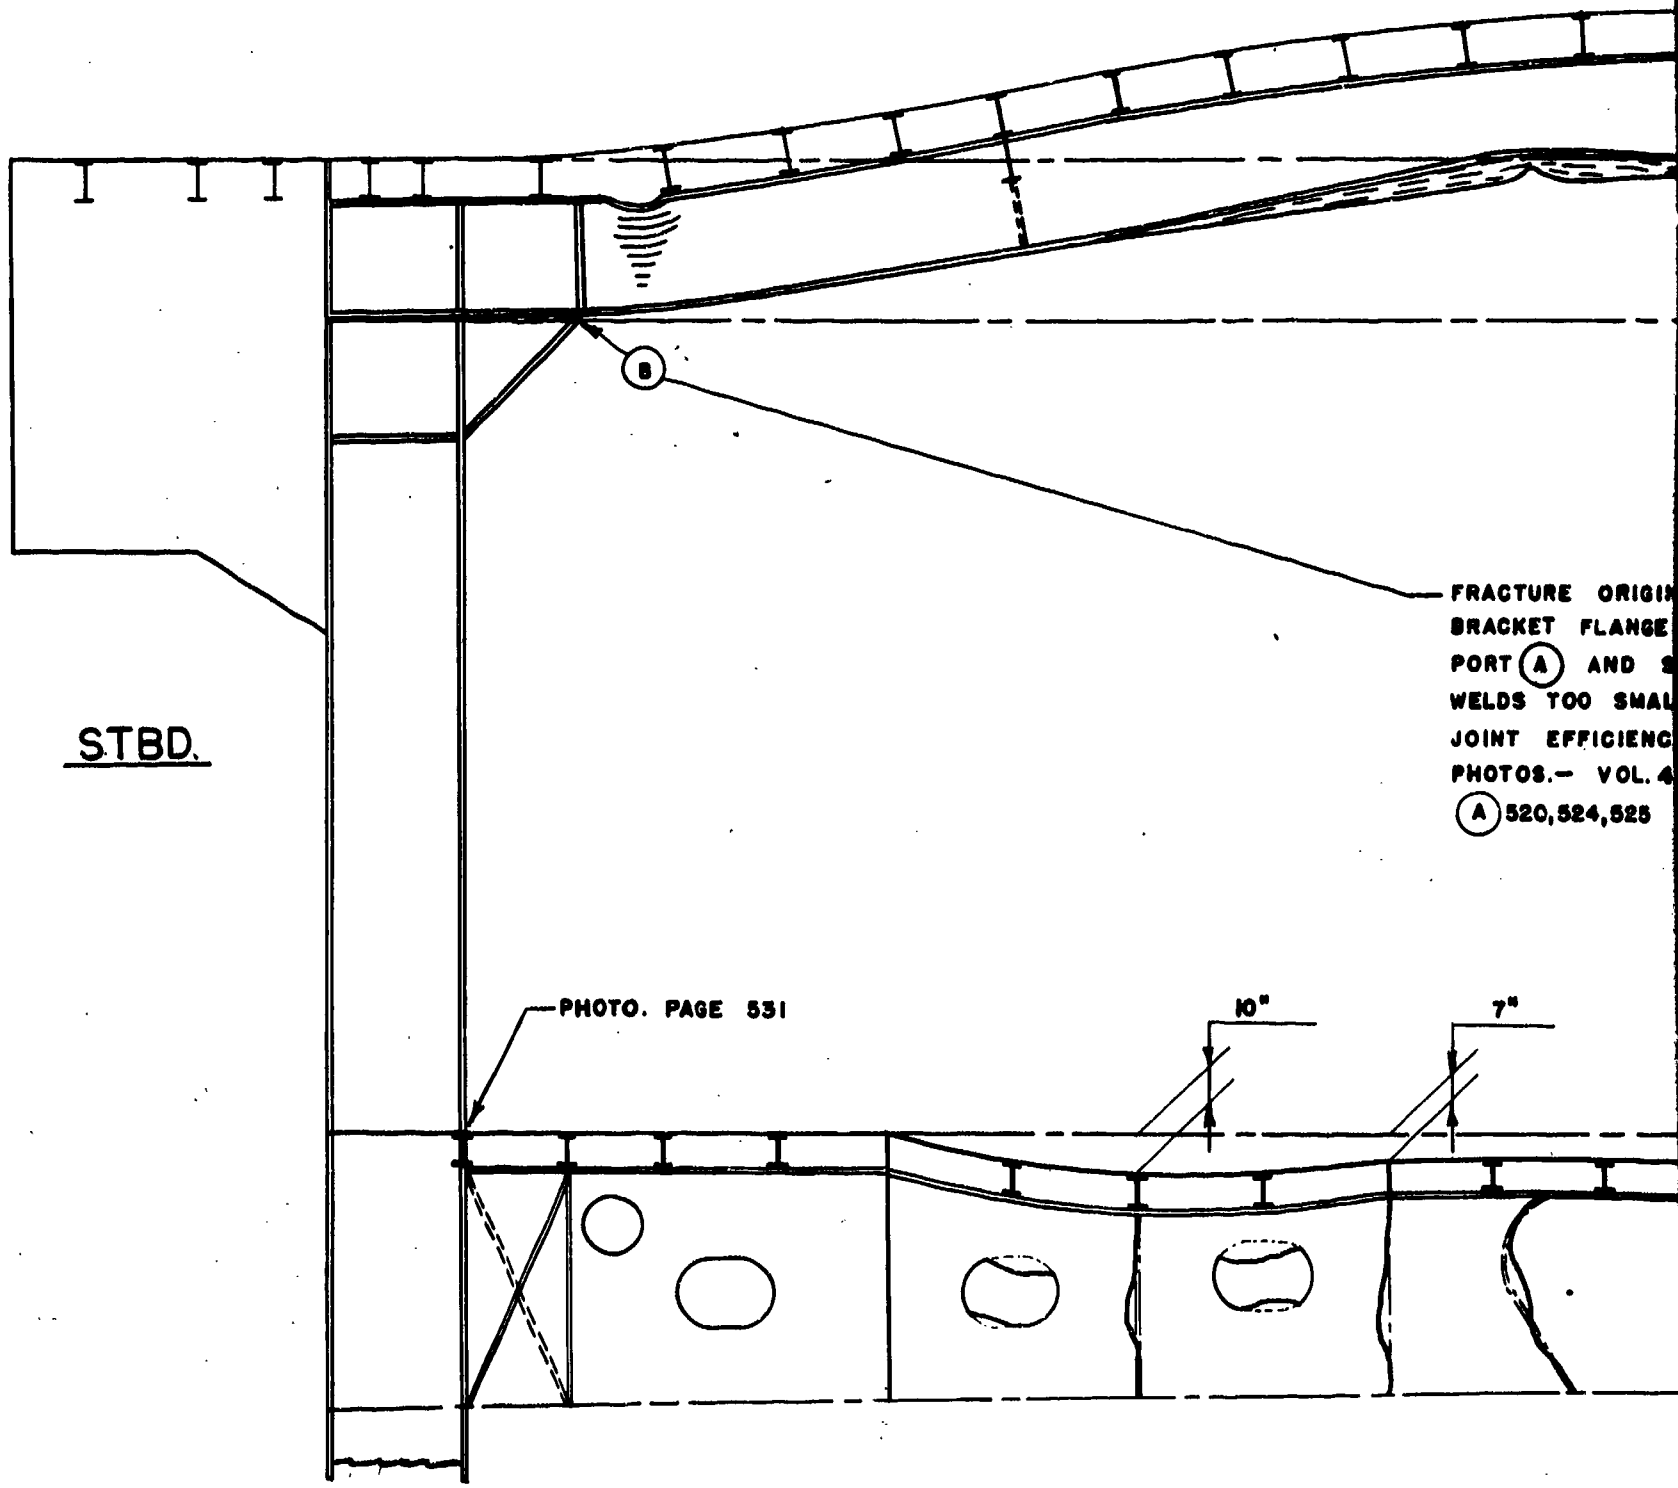
FRACTURE ORIGIN
BRACKET FLANGE
PORT (A) AND 2
WELDS TOO SMALL
JOINT EFFICIENCY
PHOTOS. - VOL. 4
(A) 520, 524, 525

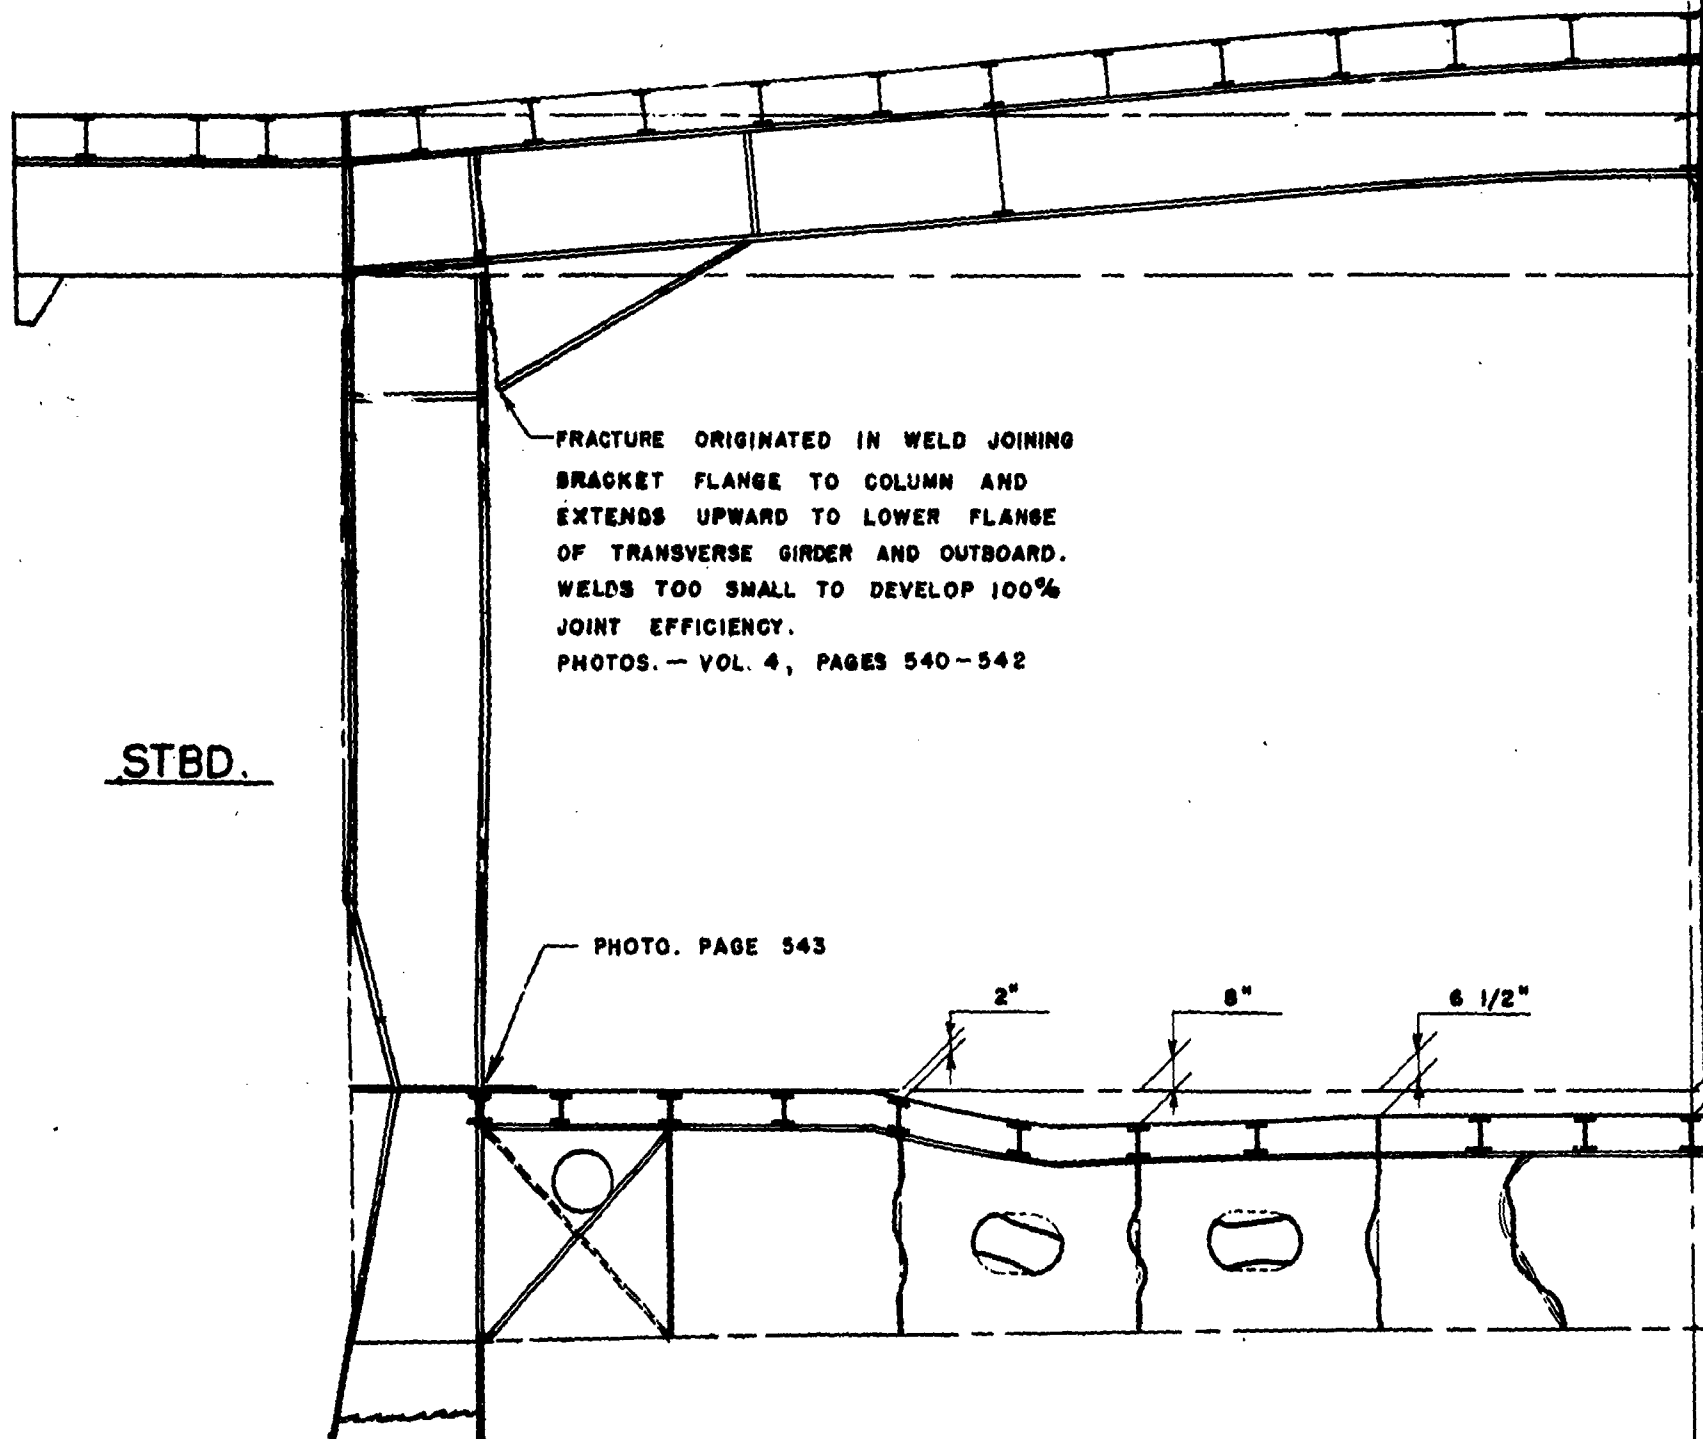
FRACTURE ORIGINATED IN WELD JOINING
BRACKET FLANGE TO COLUMN AND
EXTENDS UPWARD TO LOWER FLANGE
OF TRANSVERSE GIRDER AND OUTBOARD.
WELDS TOO SMALL TO DEVELOP 100%
JOINT EFFICIENCY.
PHOTOS. - VOL. 4, PAGES 540-542
